UNITED STATES ENVIRONMENTAL PROTECTION AGENCY

SUBJECT: Inspection Report Transmittal to Ledgeview Farms, LLC

On April 9, 2015, EPA conducted an inspection of your facility, Ledgeview Farms in De Pere, Wisconsin. The purpose of the inspection was to evaluate compliance with the Clean Water Act (CWA) and Administrative Order V-W-13-AO-22. Ledgeview Farms is a large Concentrated Animal Feeding Operation (CAFO) as defined in 40 C.F.R. § 122. During the inspection, we observed violations of the CWA and Administrative Order. The CWA and Order requires you to immediately cease all unauthorized discharges.

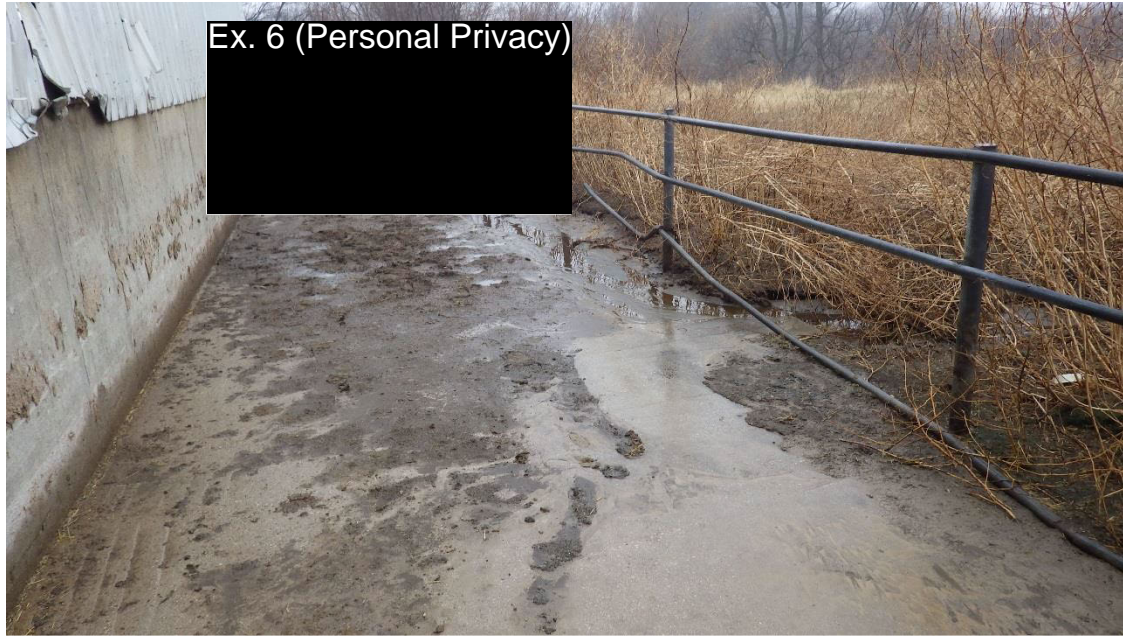
3: RIMG0011

Description: Manure and process wastewater flowed out of the northwest end of the Milk Cow Barn and from the access ways and silage bunker to the west of the Milk Cow Barn. The manure and process waste water flowed north and entered the field to the north of the Milk Cow Barn.

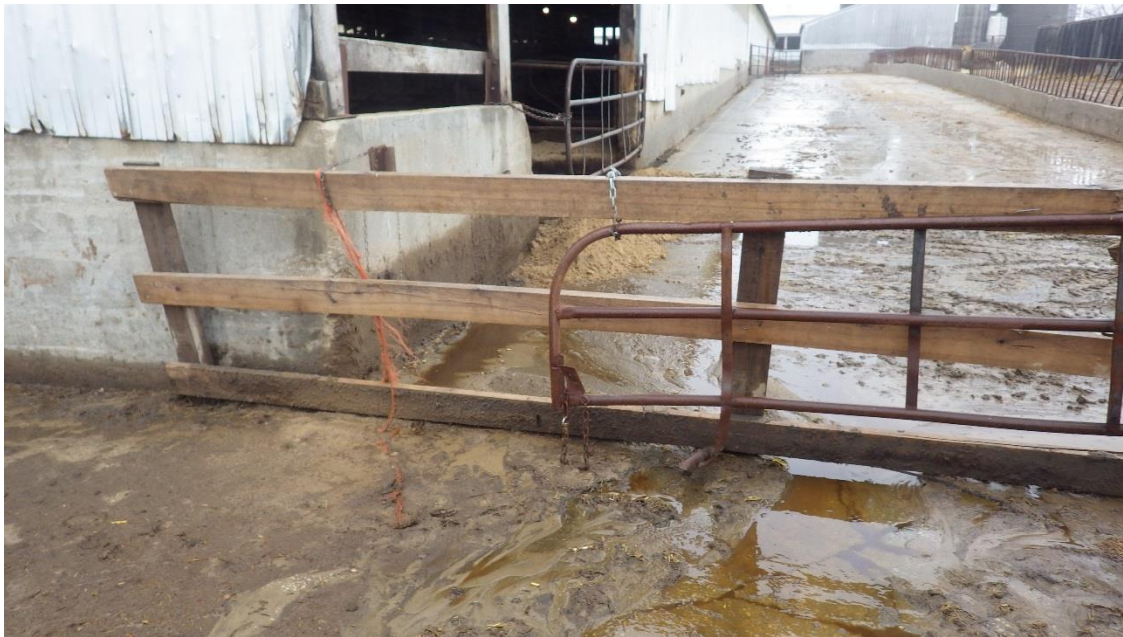
6: RIMG0014

Description: Manure and process wastewater flowed out of the northwest end of the Milk Cow Barn and from the access ways and silage bunker to the west of the Milk Cow Barn. The manure and process waste water flowed north and entered the field to the north of the Milk Cow Barn.

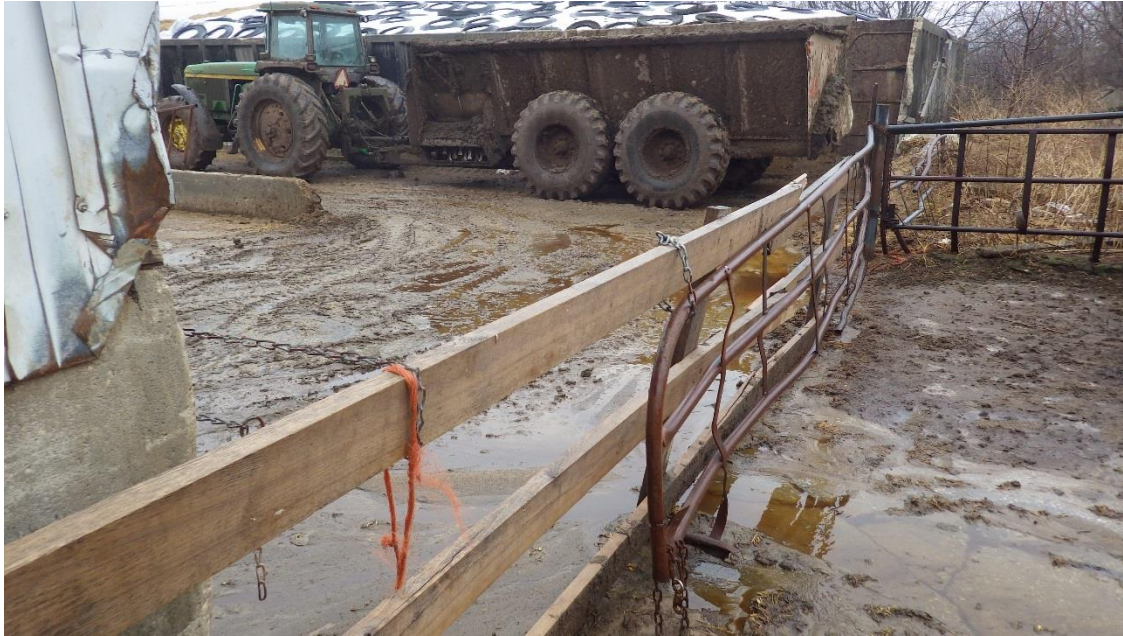
7: RIMG0015

Description: Manure and process wastewater flowed out of the northwest end of the Milk Cow Barn and from the access ways and silage bunker to the west of the Milk Cow Barn. The manure and process waste water flowed north and entered the field to the north of the Milk Cow Barn.

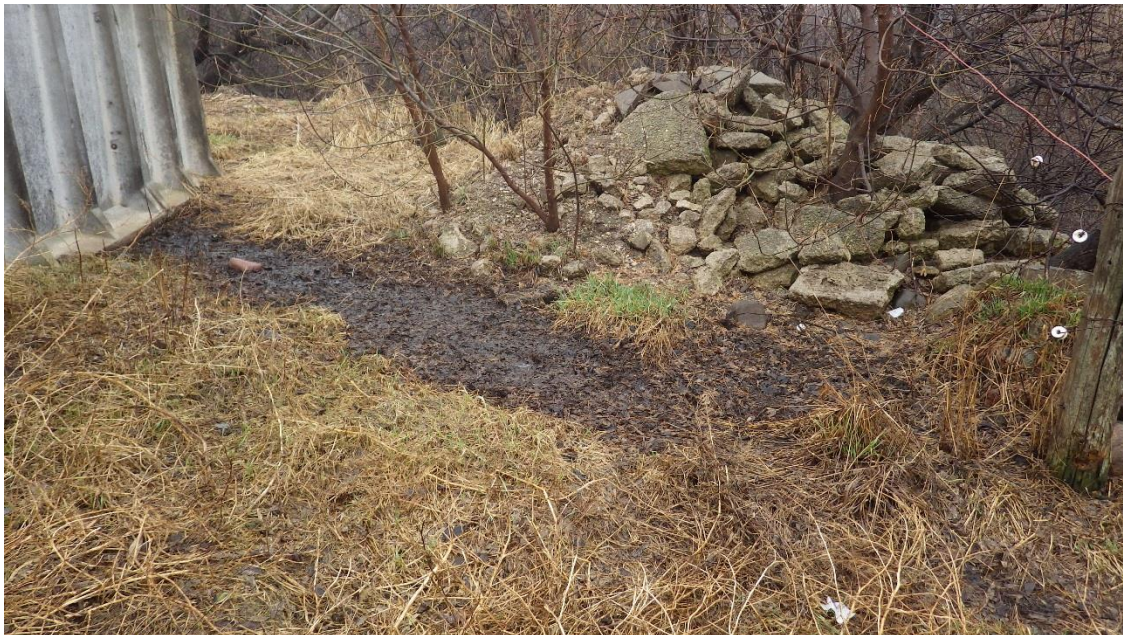
8: RIMG0016

Description: Process wastewater was observed at the north end of the Feed Bunker

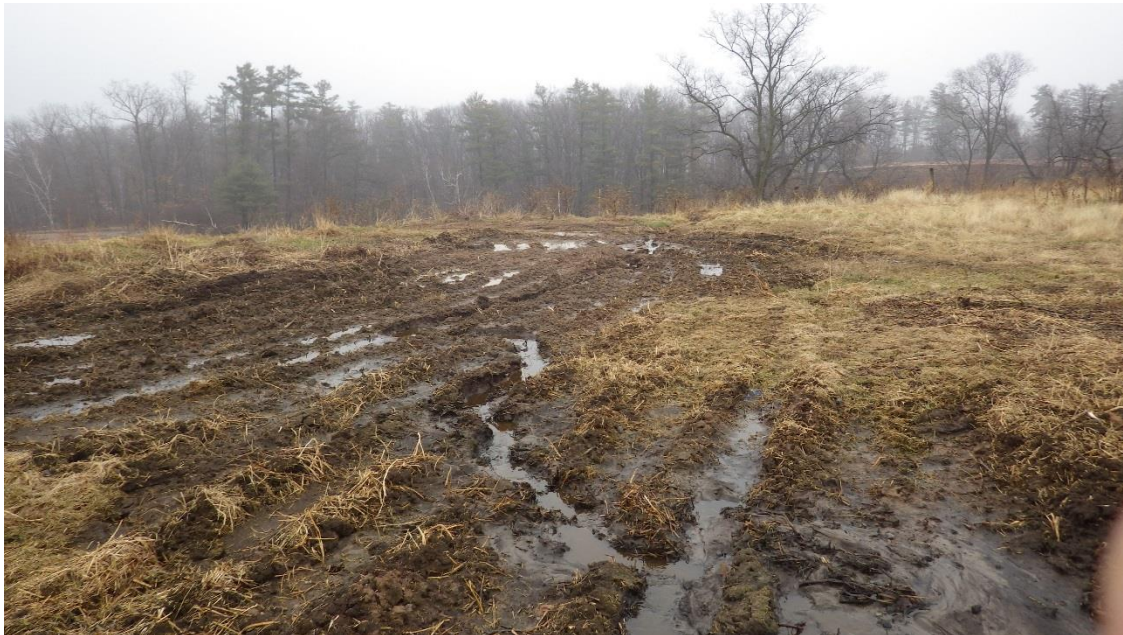
10: RIMG0018

Description: Feed, bedding, and manure solids were observed throughout the field north of the Milk Cow Barn. The field sloped to the north.

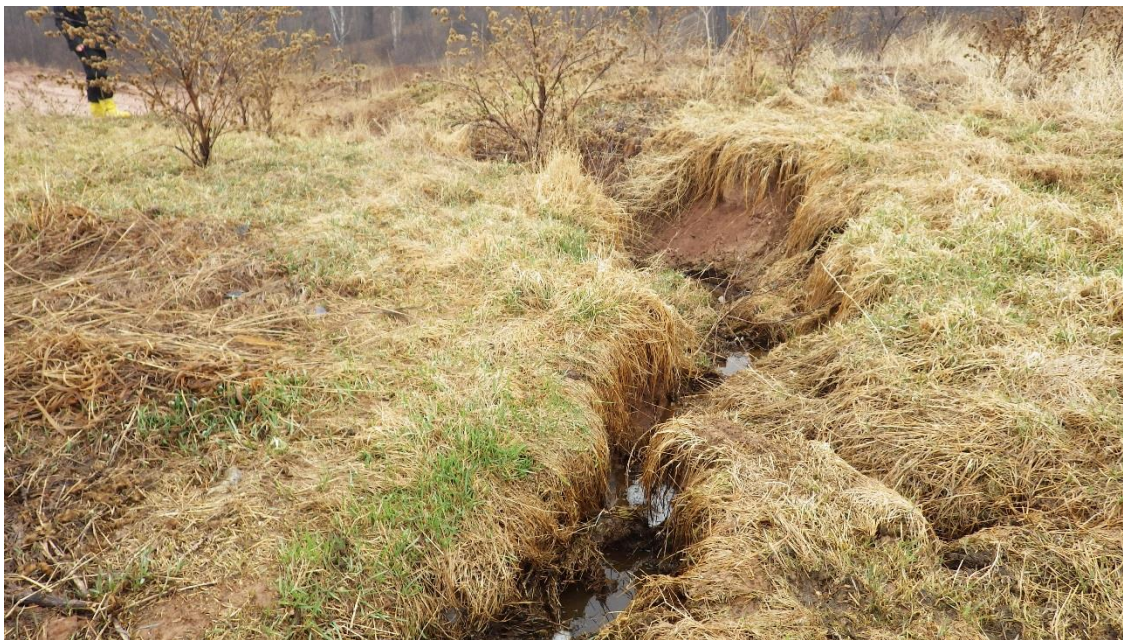
12: RIMG0020

Description: Manure and process wastewater flow from the field concentrated into a pathway.

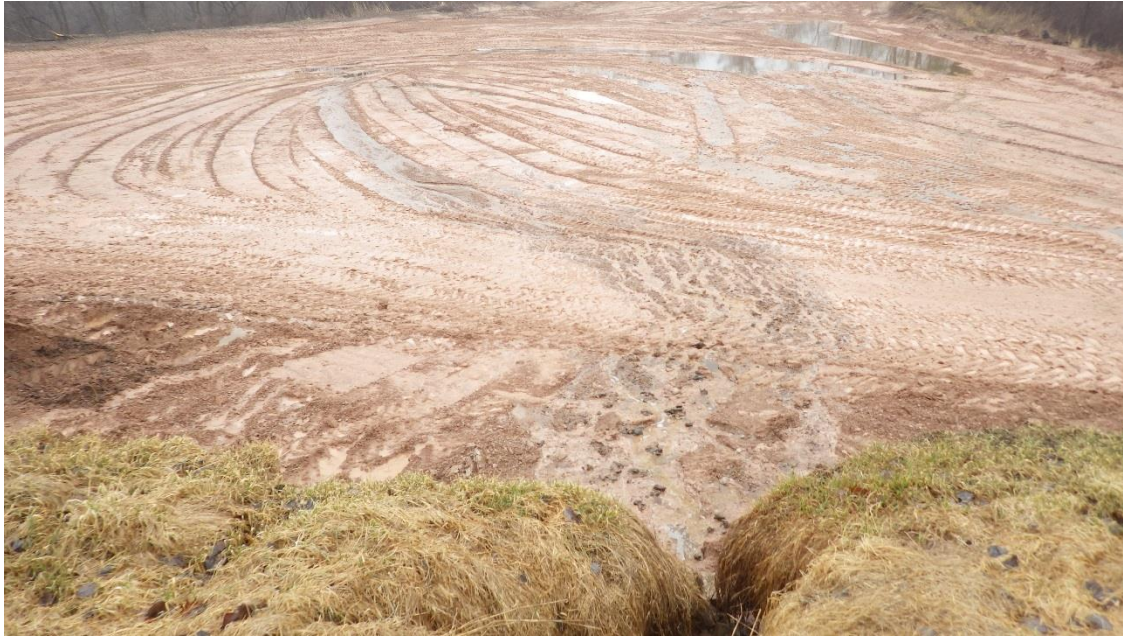
13: RIMG0021

1. At the Home site, the borrow area did not have sediment and erosion controls in place. Sediment laden storm water from the borrow area was flowing north through pathways and was observed discharging to the unnamed tributary on the east side of the Home site.

Description: The process wastewater pathway flows to the north through the borrow area north of the Milk Cow Barn. The borrow area was used for the construction of a waste storage facility. Sediment and erosion control measures had not been implemented on the disturbed area. The dark colored water in the borrow area is process wastewater.

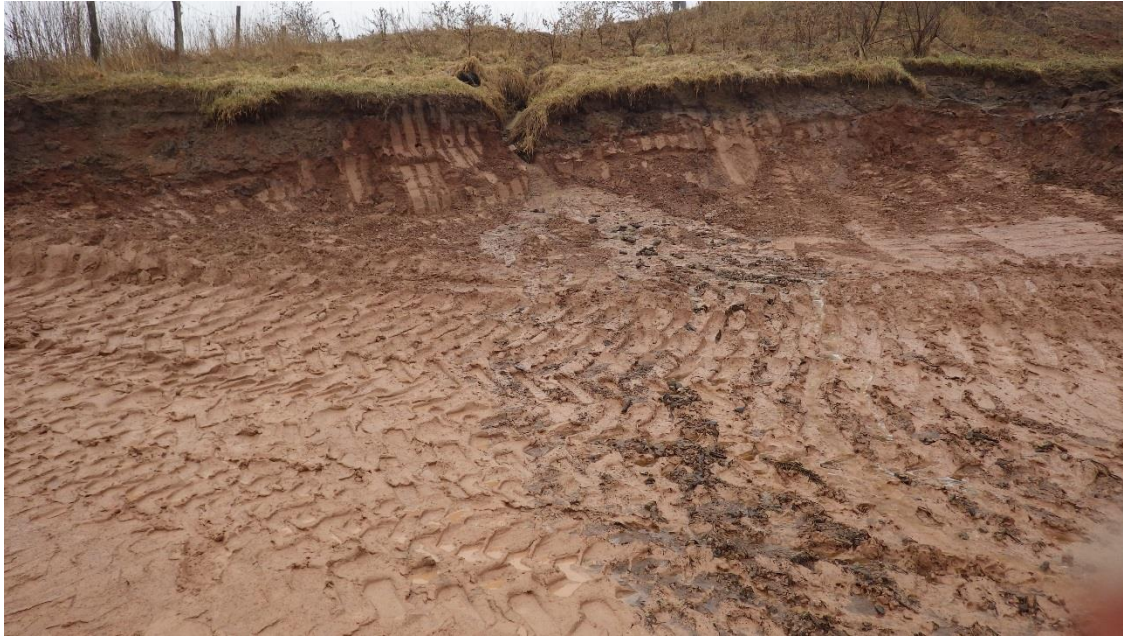
15: RIMG0024

Description: The process wastewater pathway flows to the north through the borrow area north of the Milk Cow Barn. The borrow area was used for the construction of a waste storage facility. Sediment and erosion control measures had not been implemented on the disturbed area.

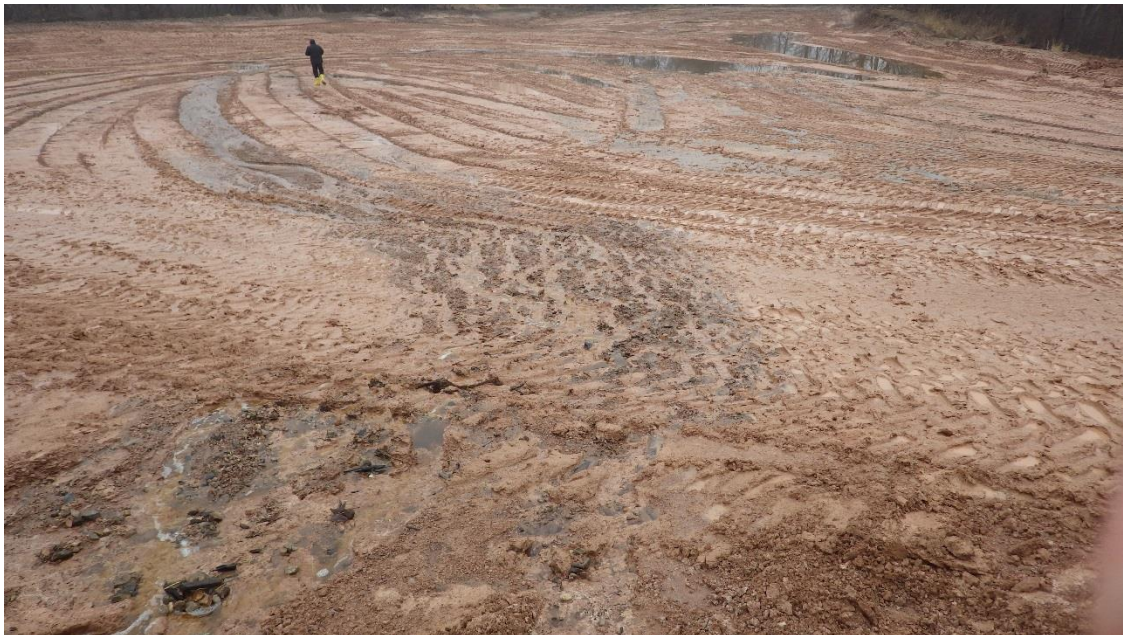
16: RIMG0025

Description: The process wastewater pathway flows to the north through the borrow area north of the Milk Cow Barn. The borrow area was used for the construction of a waste storage facility. Sediment and erosion control measures had not been implemented on the disturbed area. The dark colored water in the borrow area is process wastewater.

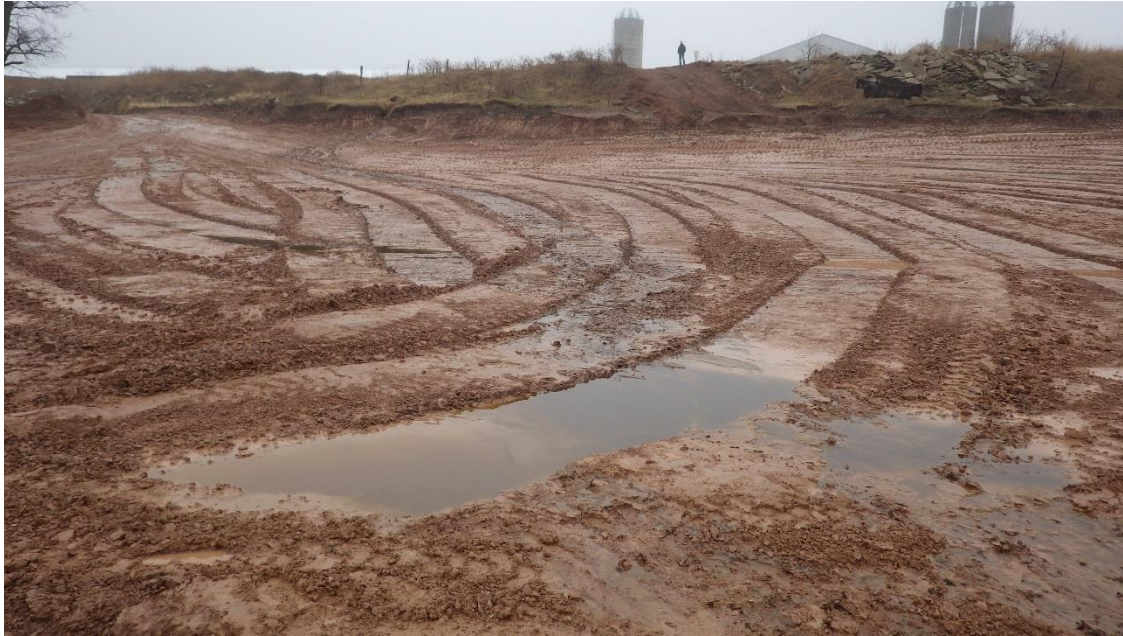
17: RIMG0026

Description: The process wastewater pathway flows to the north through the borrow area north of the Milk Cow Barn. The borrow area was used for the construction of a waste storage facility. Sediment and erosion control measures had not been implemented on the disturbed area. The dark colored water in the borrow area is process wastewater.

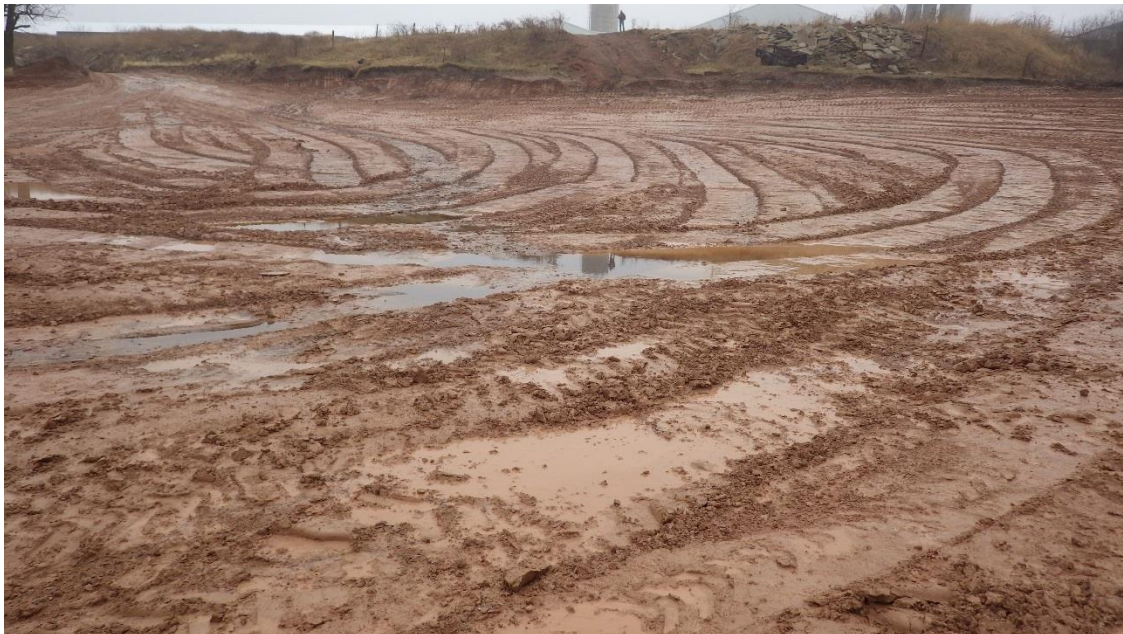
18: RIMG0027

Description: The process wastewater pathway flows to the north through the borrow area north of the Milk Cow Barn. The borrow area was used for the construction of a waste storage facility. Sediment and erosion control measures had not been implemented on the disturbed area. The dark colored water in the borrow area is process wastewater.

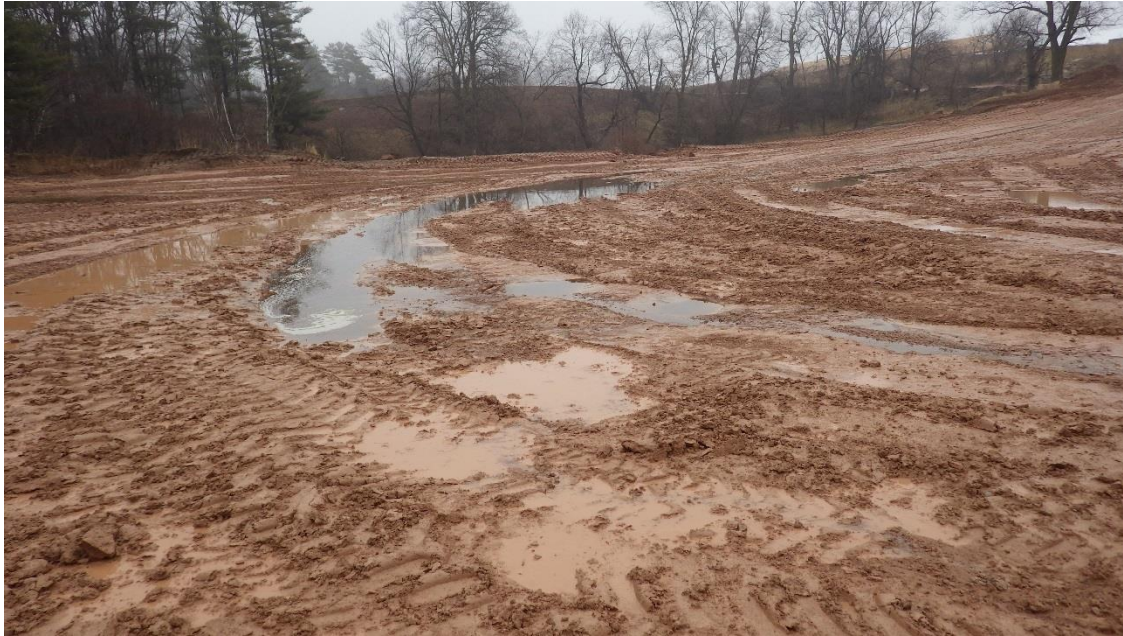
19: RIMG0028

Description: The process wastewater pathway flows to the north through the borrow area north of the Milk Cow Barn. The borrow area was used for the construction of a waste storage facility. Sediment and erosion control measures had not been implemented on the disturbed area. The dark colored water in the borrow area is process wastewater.

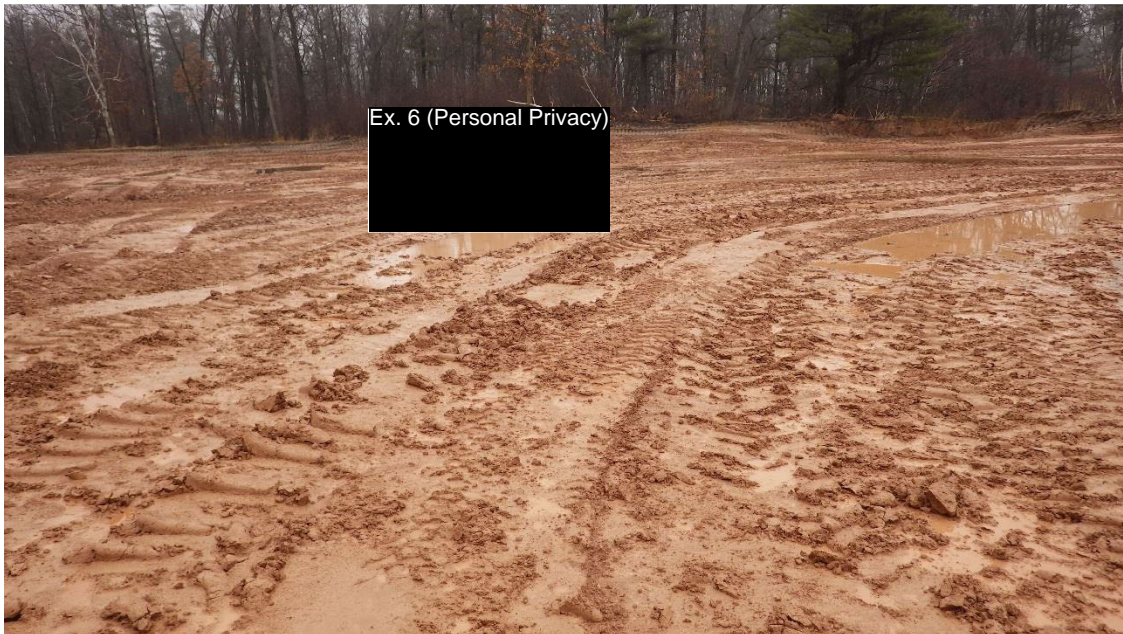
20: RIMG0029

Description: The process wastewater pathway flows to the north through the borrow area north of the Milk Cow Barn. The borrow area was used for the construction of a waste storage facility. Sediment and erosion control measures had not been implemented on the disturbed area. The dark colored water in the borrow area is process wastewater.

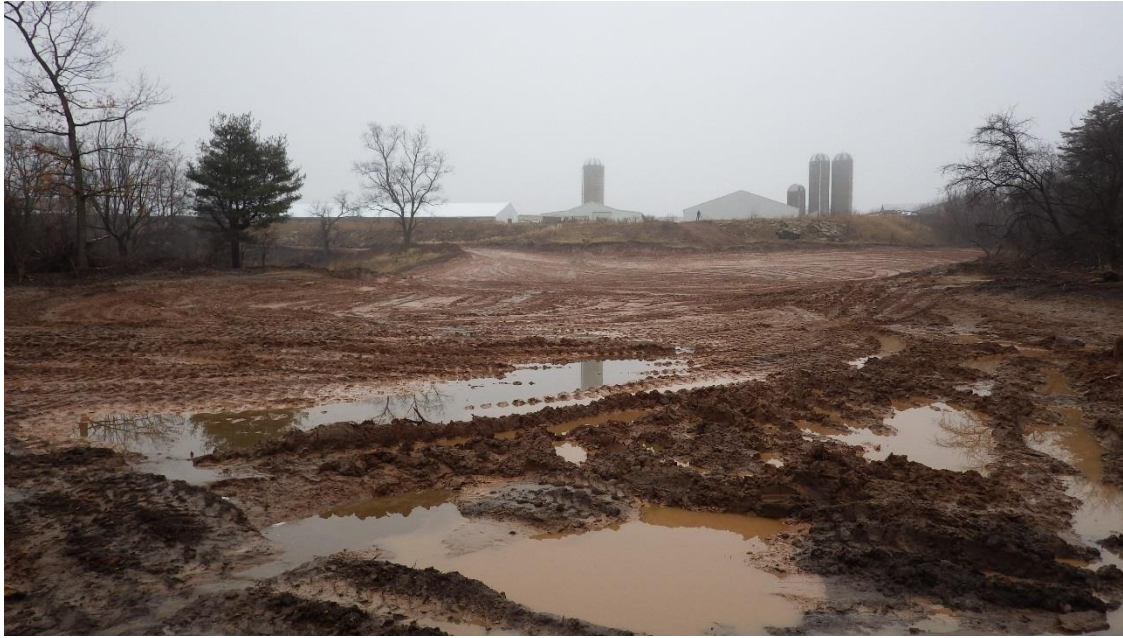
21: RIMG0030

Description: The process wastewater pathway flows to the north through the borrow area north of the Milk Cow Barn. The topography of the disturbed field is sloped such that the flow continues north into a wooded area. There were no sediment and erosion controls to reduce the amount of sediment transferred off site.

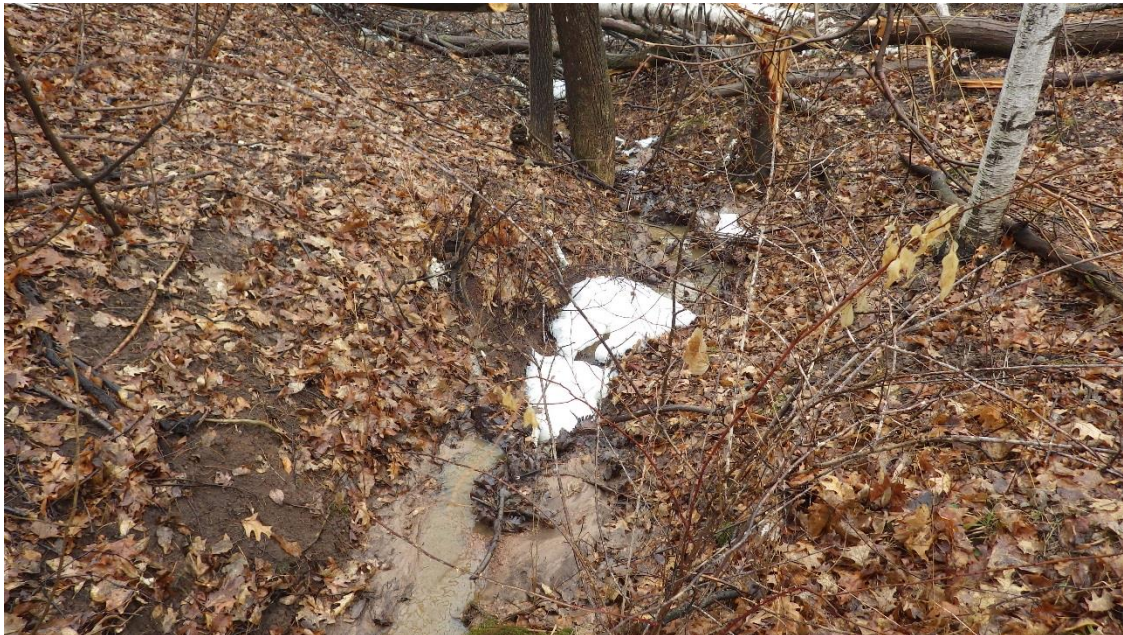
28: RIMG0037

Description: The process wastewater pathway flows to the north through a wooded area. Foam was observed in multiple locations throughout the pathway.

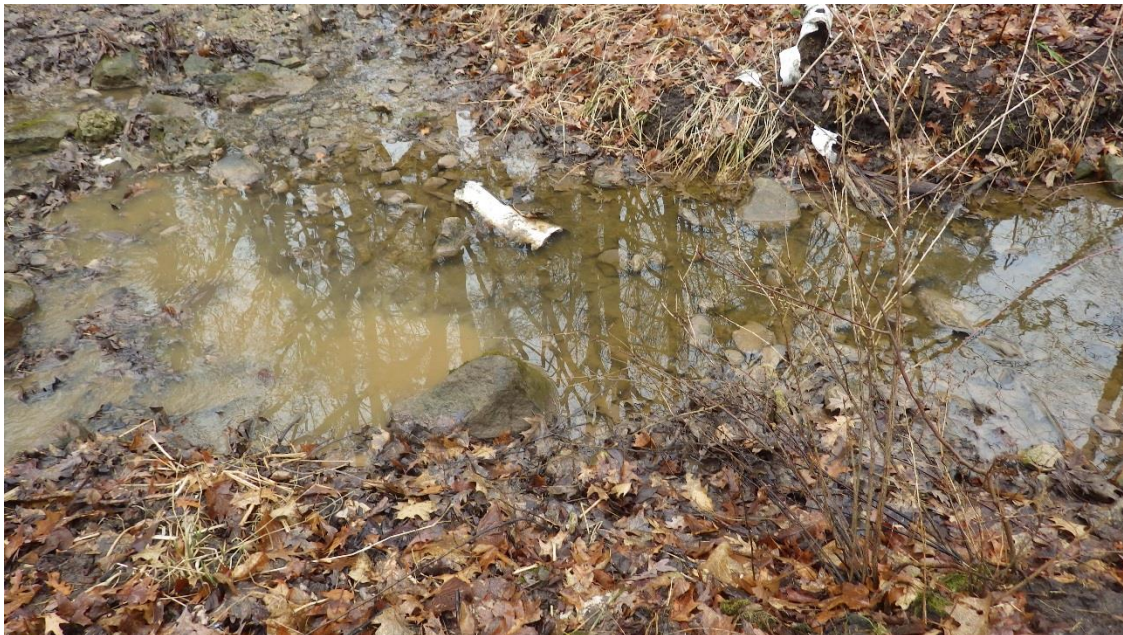
34: RIMG0043

1. At the Home site, process wastewater was trickling out of the northwest corner of the concrete pit and was observed in a depressional area. The depressional area drained north through pathways and was observed discharging to the unnamed tributary on the east side of the Home site.

Description: The process wastewater pathway entered the unnamed tributary that abuts the east side of the Home site. The turbid water on the left hand side of the photo from the flow pathway mixed with the clear water from the upstream portion of the unnamed tributary.

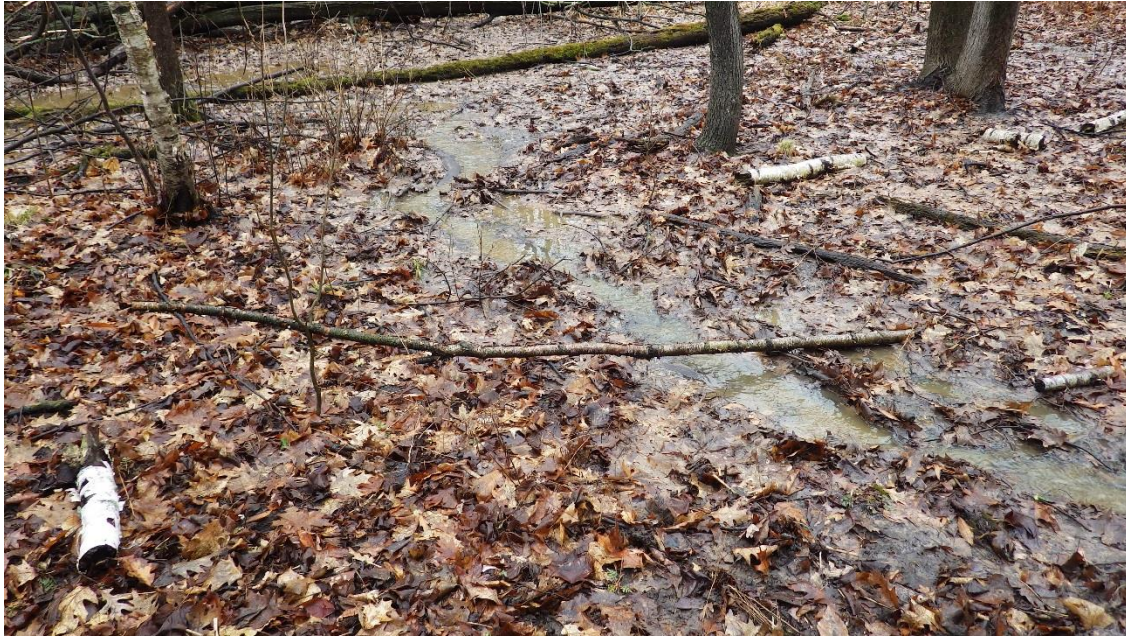
37: RIMG0046

Description: The process wastewater pathway flowing east to the unnamed tributary that abuts the east side of the Home site.

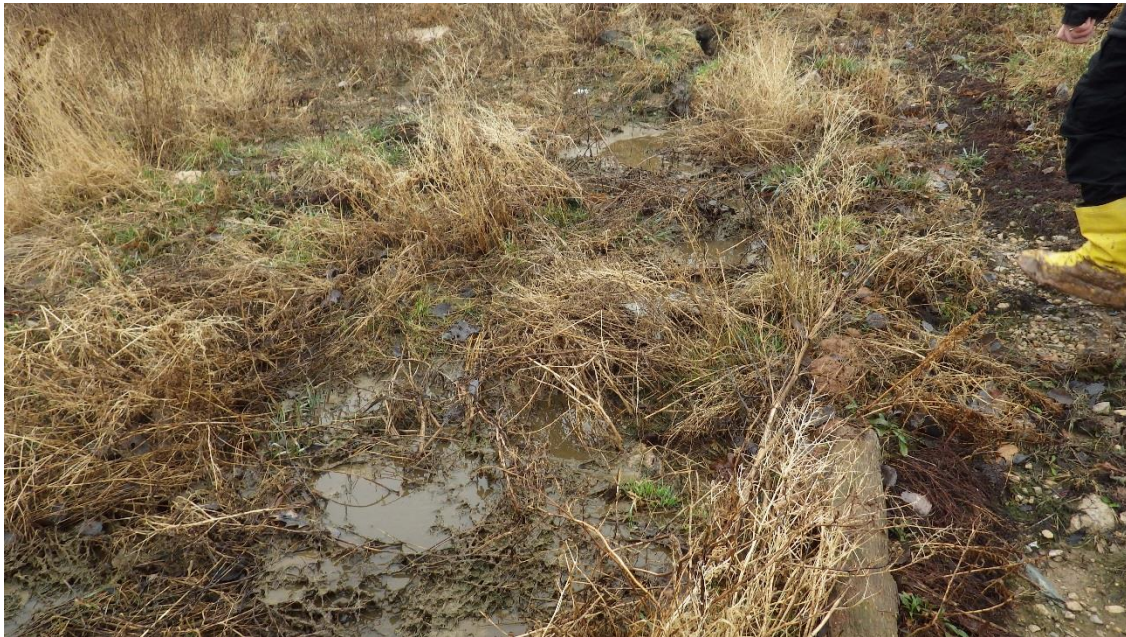
38: RIMG0047

3. At the Home site, manure and process wastewater from the New Barn, cattle walkways, and the barn west of the New Barn did not have containment and was flowing north through pathways and was observed discharging to the unnamed tributary on the east side of the Home site.

Description: Process wastewater flowed to the north to the borrow area north of the Milk Cow Barn. This process wastewater was emanating from the New Barn, the barn west of the New Barn, and the access ways between these barns.

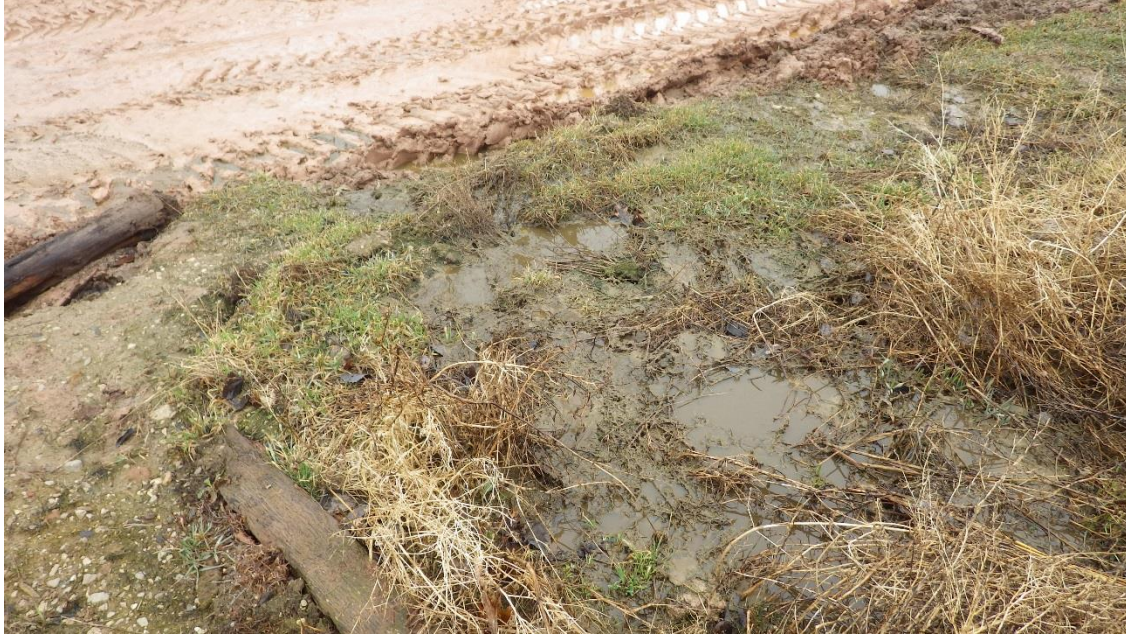
39: RIMG0048

Description: Process wastewater flowed to the north to the borrow area north of the Milk Cow Barn. This process wastewater was emanating from the New Barn, the barn west of the New Barn, and the access ways between these barns.

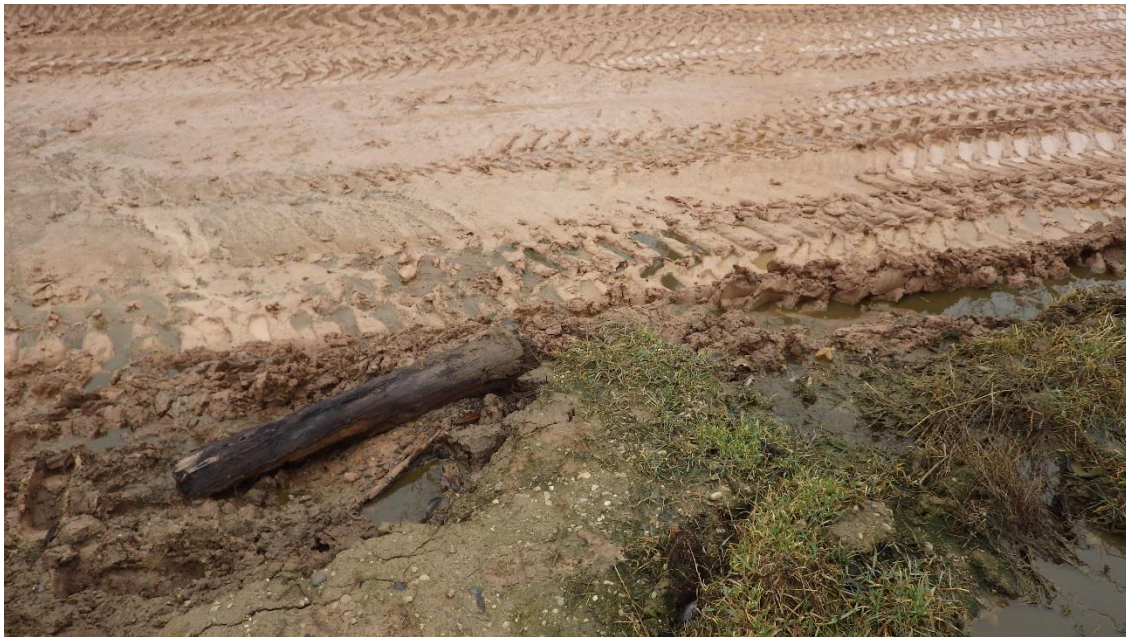
40: RIMG0049

Description: Process wastewater flowed to the north to the borrow area north of the Milk Cow Barn. This process wastewater was emanating from the New Barn, the barn west of the New Barn, and the access ways between these barns.

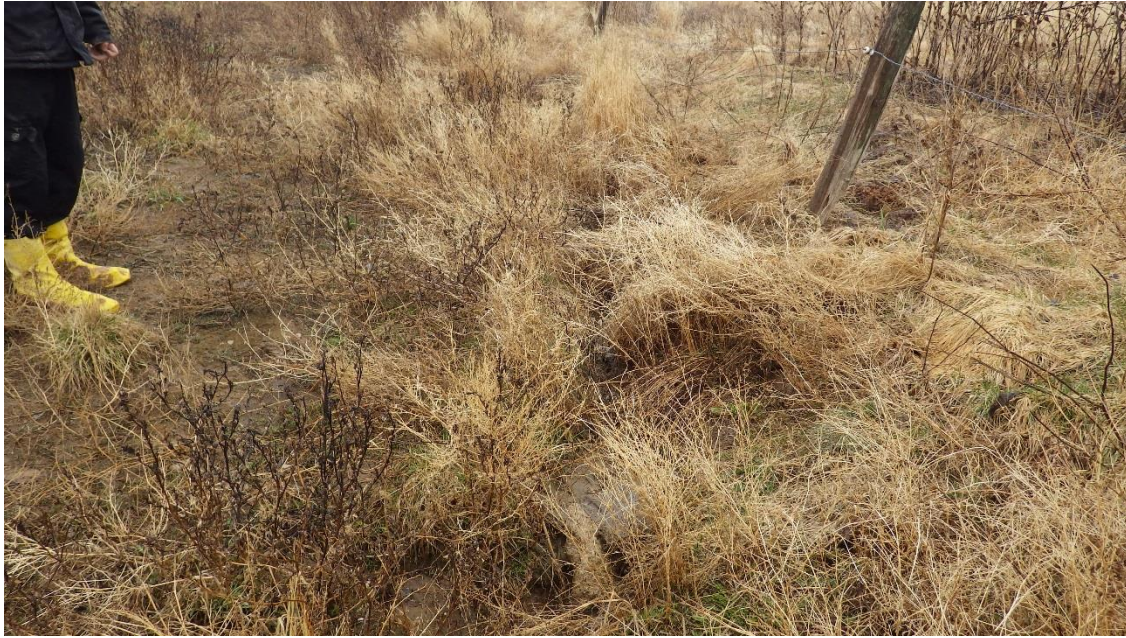
41: RIMG0050

Description: Process wastewater flowed through a pathway to the north to the borrow area north of the Milk Cow Barn. This process wastewater was emanating from the New Barn, the barn west of the New Barn, and the access ways between these barns.

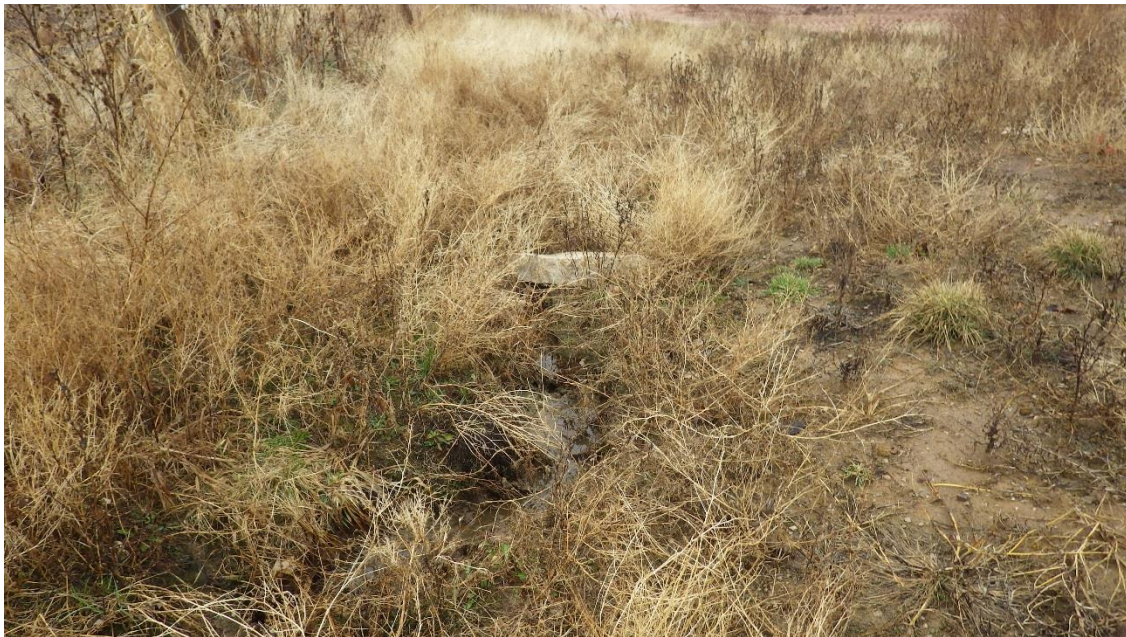
42: RIMG0051

Description: Process wastewater flowed through a pathway to the north to the borrow area north of the Milk Cow Barn. This process wastewater was emanating from the New Barn, the barn west of the New Barn, and the access ways between these barns.

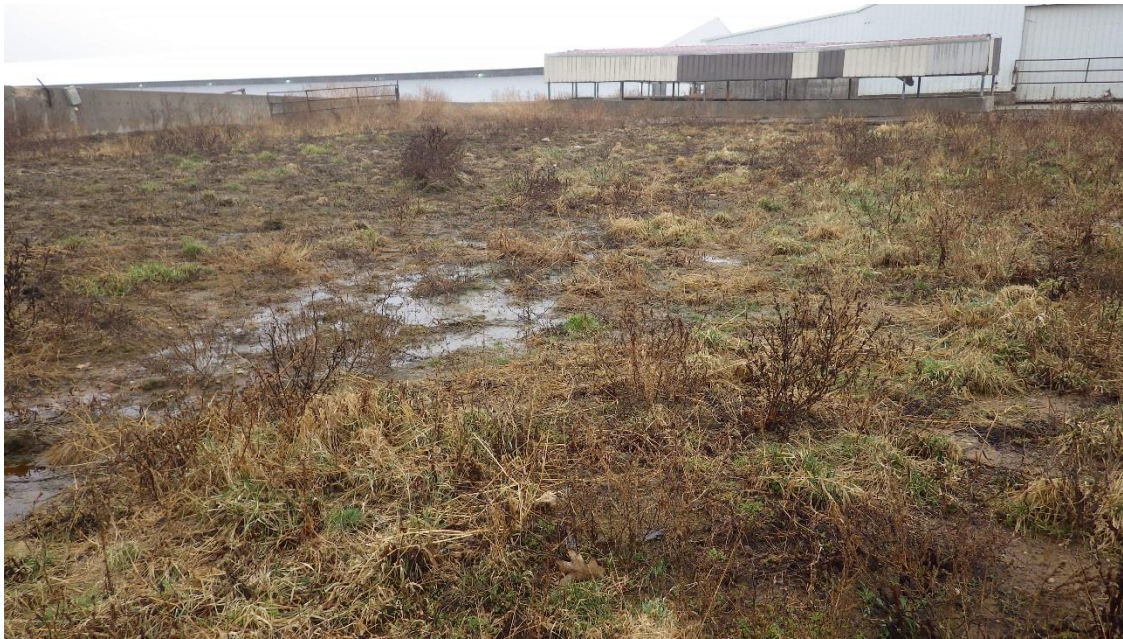
43: RIMG0052

Description: Process wastewater in the field west of the concrete pits.

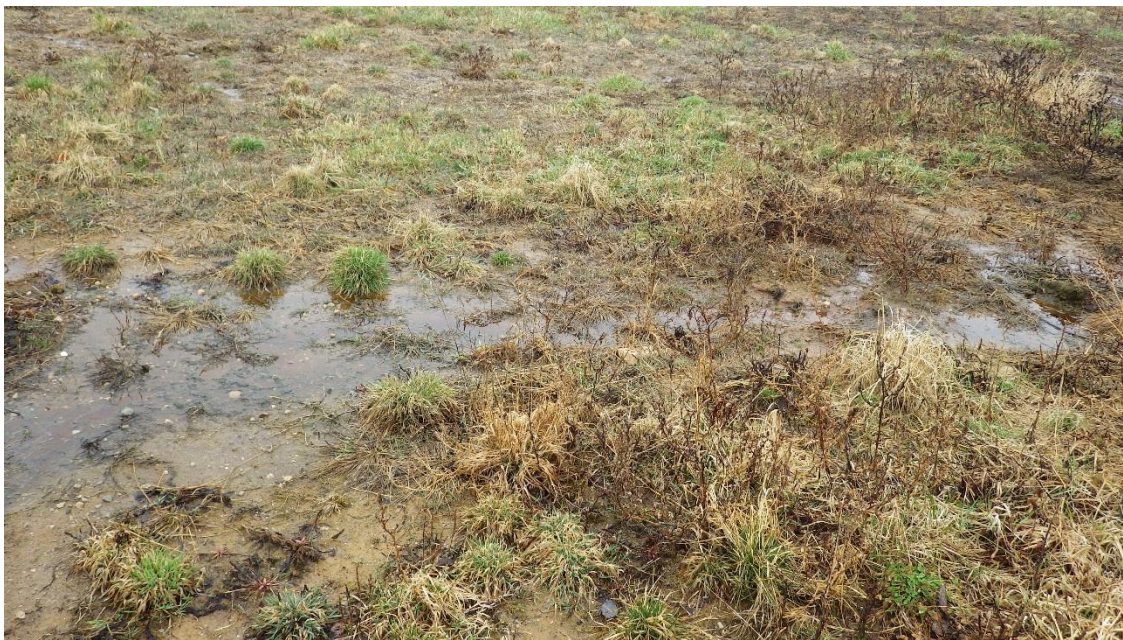
44: RIMG0053

Description: Process wastewater in the field west of the concrete pits.

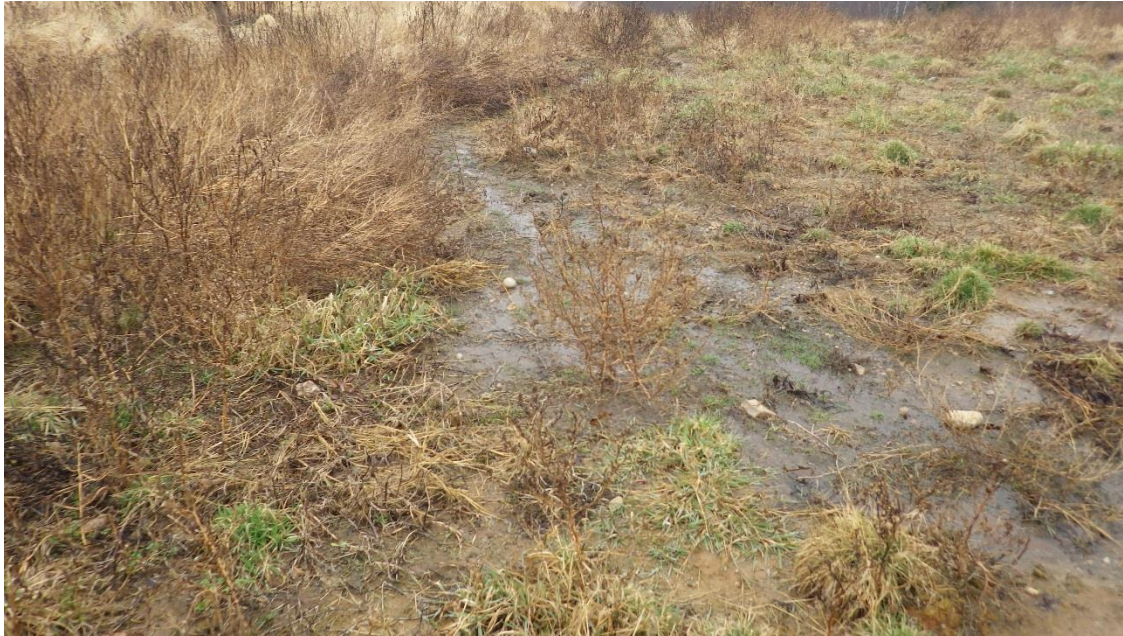
45: RIMG0054

Description: Process wastewater in the field west of the concrete pits.

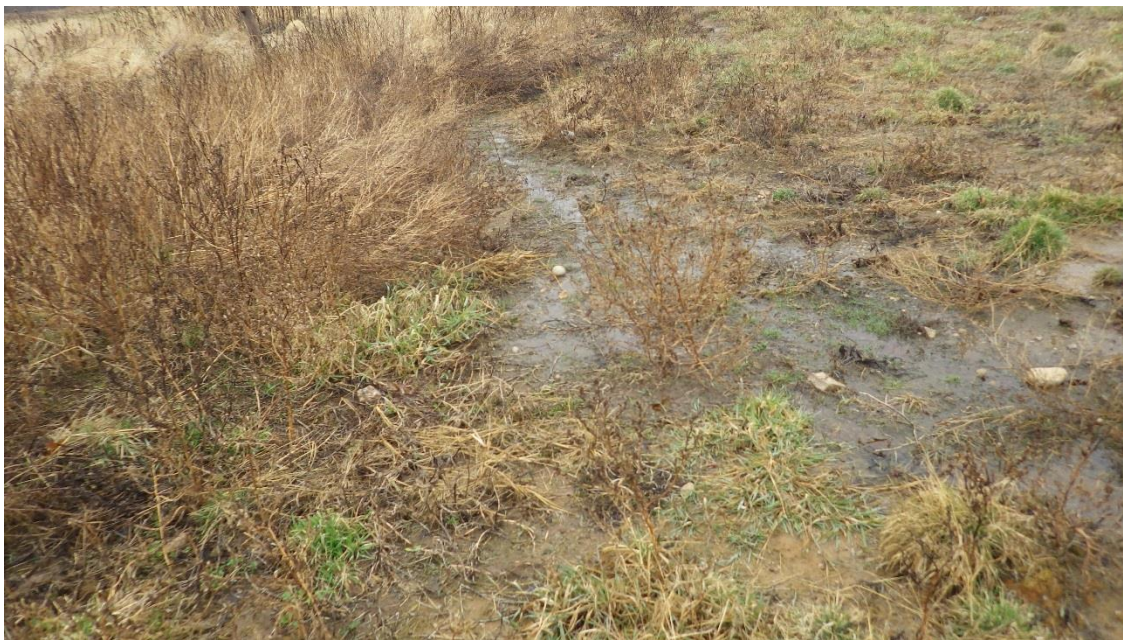
46: RIMG0055

Description: Process wastewater in the field west of the concrete pits.

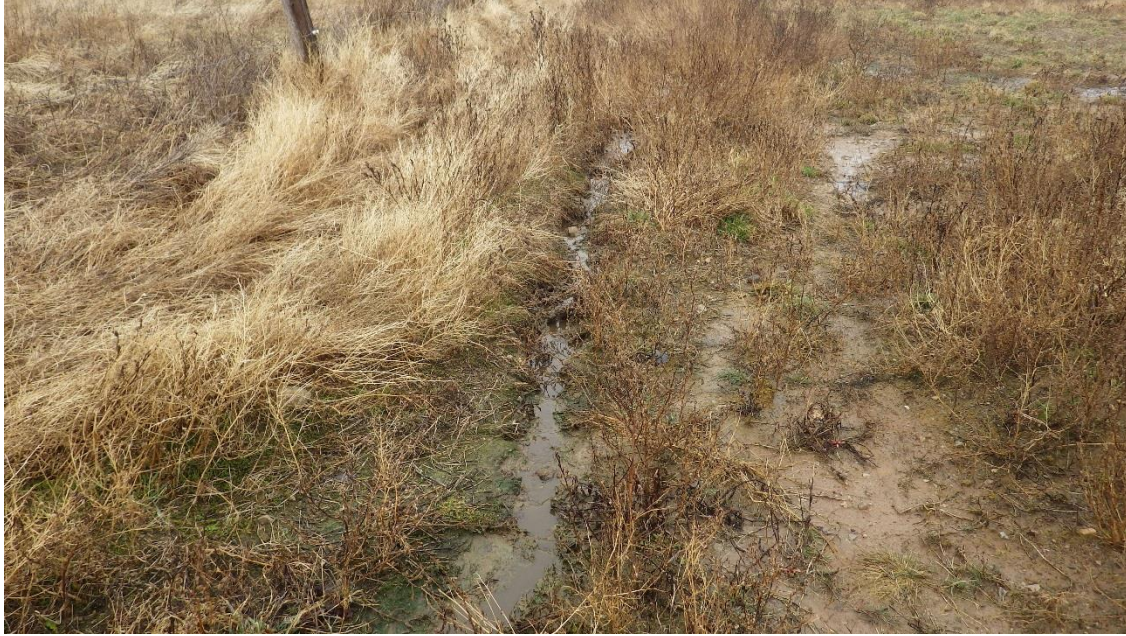
47: RIMG0056

Description: Process wastewater flowed through a pathway to the north to the borrow area north of the Milk Cow Barn. This process wastewater was emanating from the New Barn, the barn west of the New Barn, and the access ways between these barns.

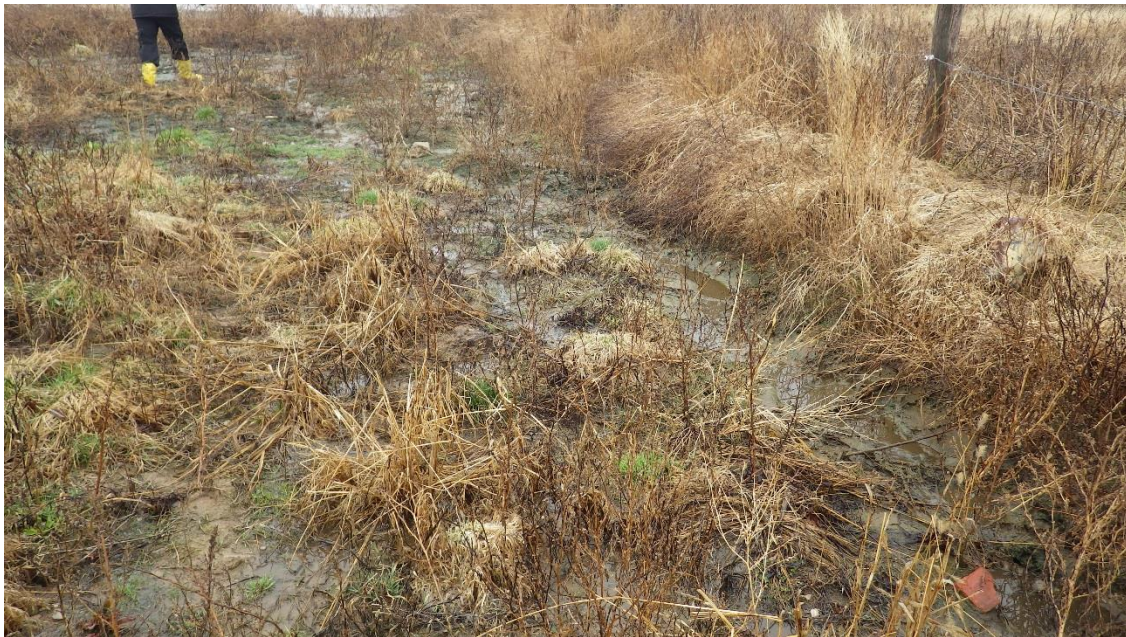
48: RIMG0057

Description: Process wastewater flowed through a pathway to the north to the borrow area north of the Milk Cow Barn. This process wastewater was emanating from the New Barn, the barn west of the New Barn, and the access ways between these barns.

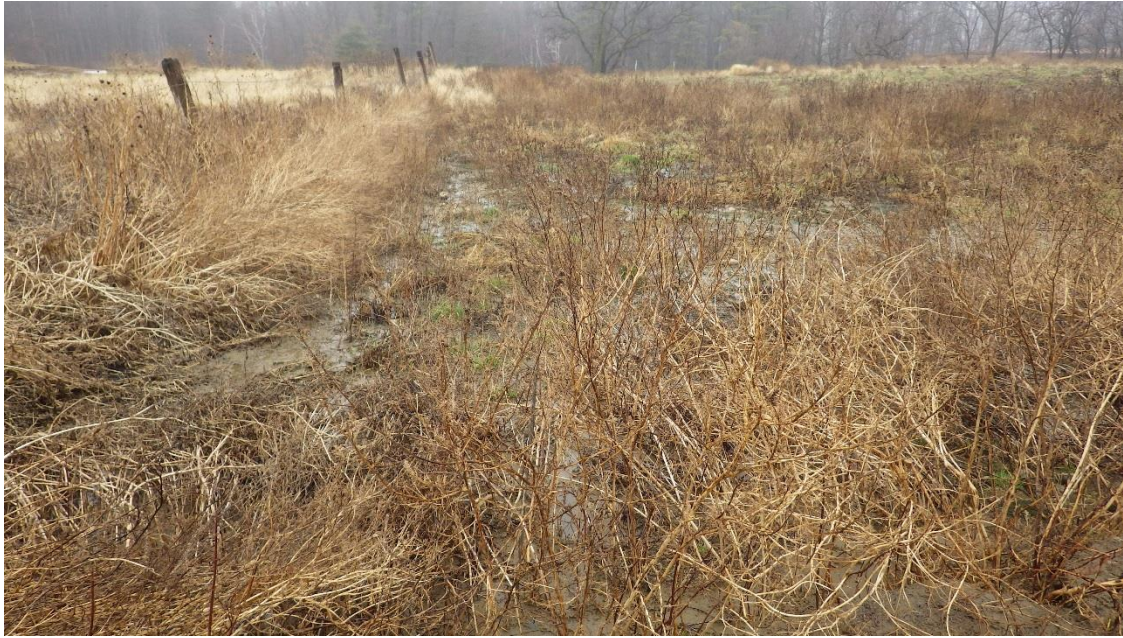
49: RIMG0058

Description: Process wastewater flowed through a pathway to the north to the borrow area north of the Milk Cow Barn. This process wastewater was emanating from the New Barn, the barn west of the New Barn, and the access ways between these barns.
